Base test report

Micro diesel prototypes

June 2008

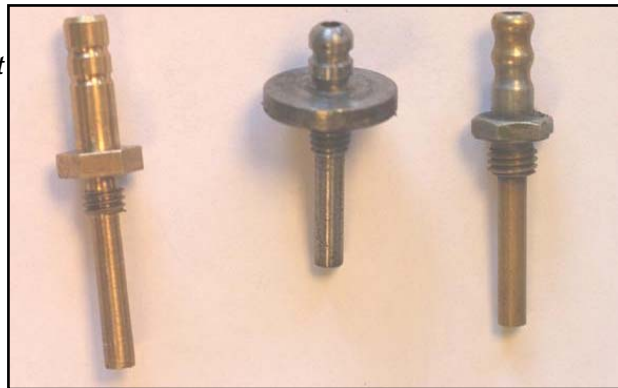
Picture showing the 3 needle valves from the different prototypes. From the left to the right:

- Prototype 2; 'Dutch engine'
- Prototype 3; 'Chinese engine'
- Prototype 1; 'original engine'

The Dutch needle valve came closest to the measurements of the Lohmann engine, the sizes B and C were machined to replicate the original.

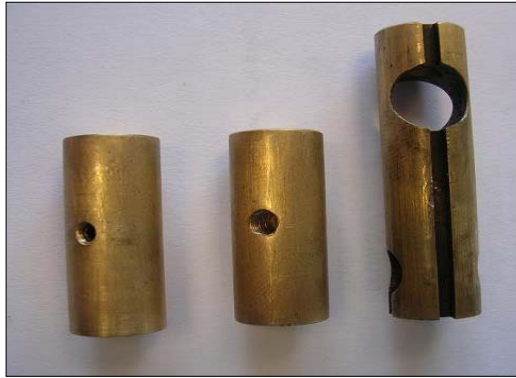
Picture on the right shows both the 2 prototype valves on the left and the original valve on the right.

In the picture above first the two available valves for the test (Chinese and Dutch) are shown. The 3rd is the original air valve that was not present during testing.

The Dutch air valve had measurements closest to the original and has therefore been selected for use in the test.

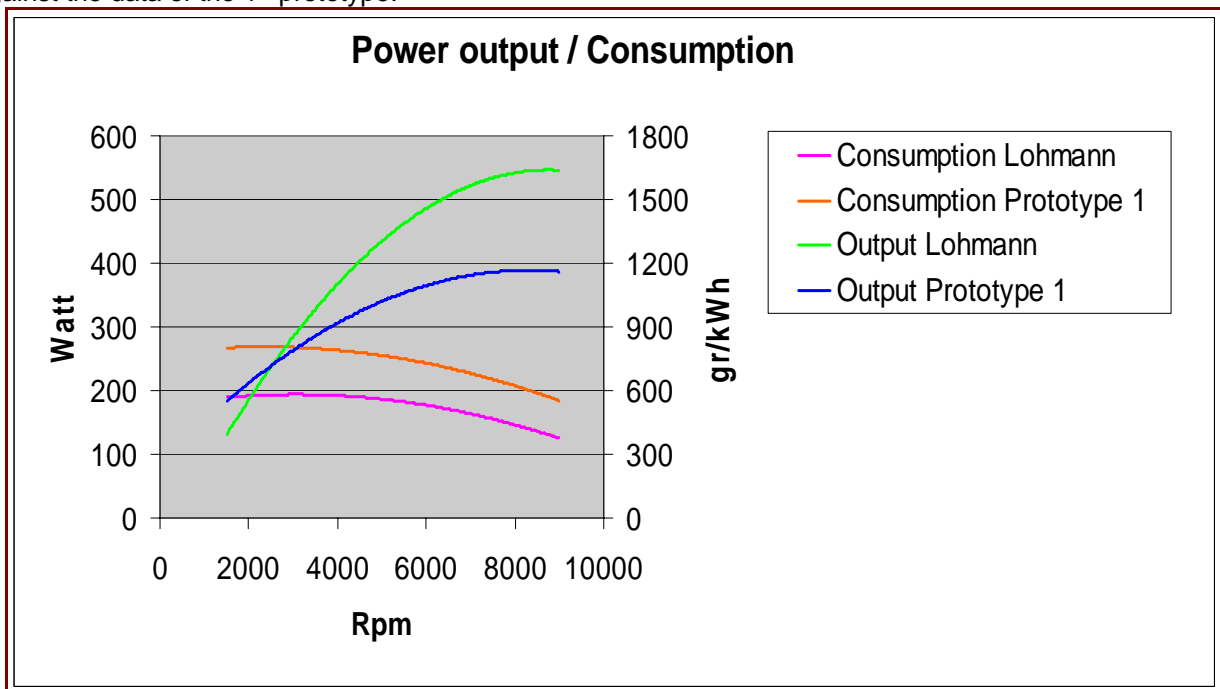
In the figure below the specific consumption data and output data² of the original Lohmann engine is set against the data of the 1st prototype.

As can be seen in the above picture, both the specific consumption and output of the original Lohmann engine are better.

The reason why the original Lohmann data shows a better result, might be due to a couple of things:

- state of prototype 1 (leak path between cylinder and piston because of scratches)
- composition of the kerosene used for testing
- reliability of the original data sheet

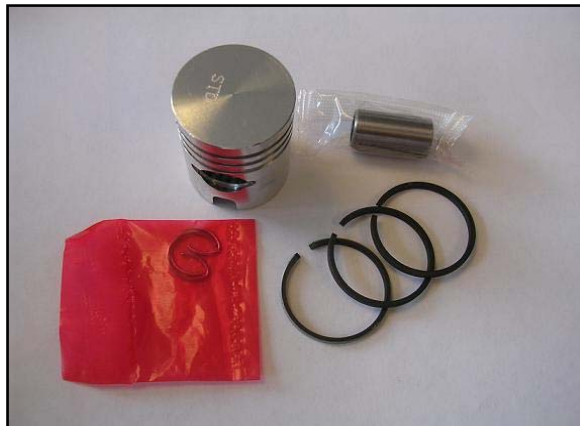
Chinese piston setup

In China a series of 250 piston sets have been produced for the micro diesel engine development, one set exists of:

- 1 piston
- 3 piston rings
- 1 gudgeon pin
- 2 circlips

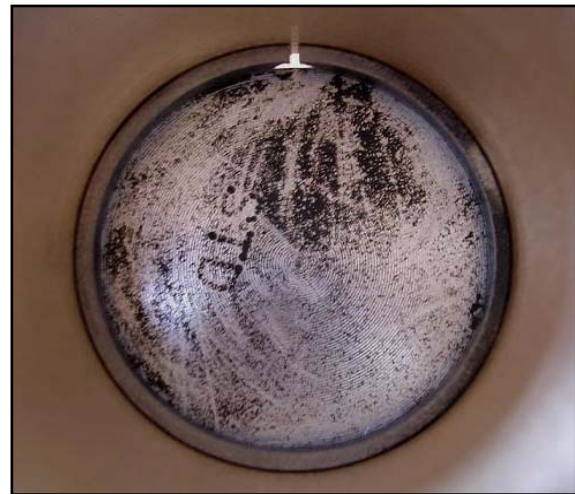
The left picture (below) gives an example of a Chinese piston ring in a cylinder barrel-size bushing. On the right an original ring in the same bushing.

Chinese made piston ring

Original piston ring

The difference can easily be seen: the Chinese ring not only has a ring gap where light is visible, but also along the circumference there is a clearance where light can pass. This means that the Chinese rings compared to the original rings would have more leakage past the rings with a similar gap size.

The Chinese piston rings do not make a good enough seal. For a self igniting engine the seal it makes is not sufficient to reach a pressure at which the fuel mixture will self-ignite.

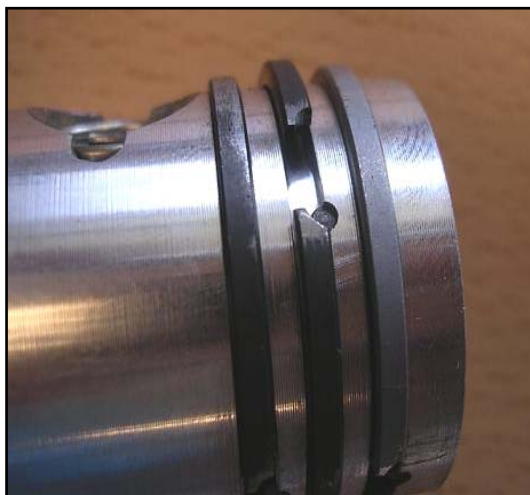
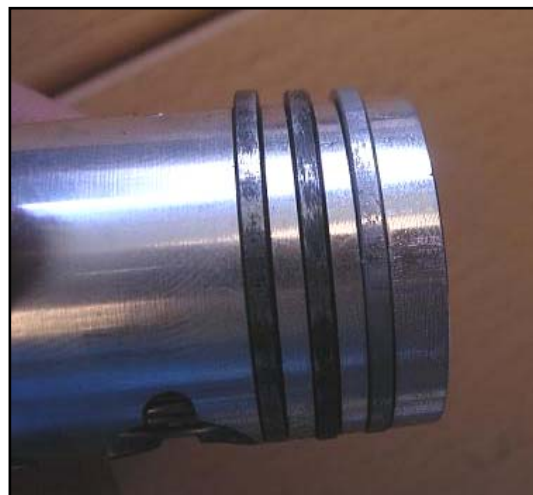
After the light check, the Chinese piston and rings were removed from the Dutch engine to be inspected. The rings had a thin protective coating that was partly worn on the places where it touched the circumference of the cylinder barrel. The parts that did not touch the cylinder barrel circumference still had the protective layer. As can be seen on the left picture below (looking at the middle ring), the ring ends forming the ring-gap have lost its protective layer and are shiny. The parts beside the ends are still completely coated black. The right picture is showing the opposite side of the middle ring, which is much more evenly worn.

At the ring gap its worn locally

At the opposite side its evenly worn

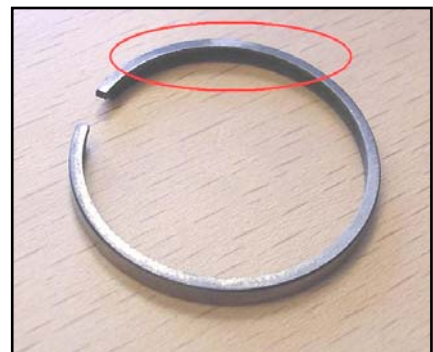
Bottom of middle piston ring, with a circle around the clean patch.

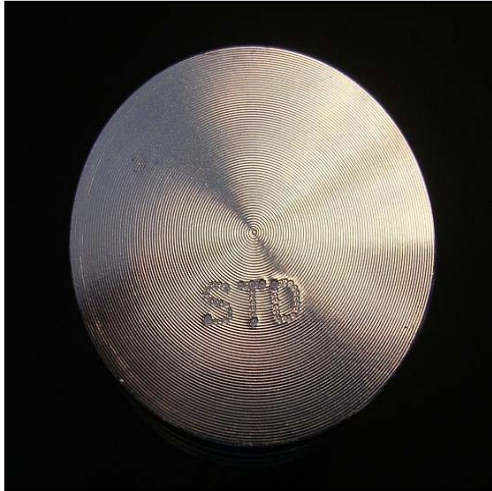
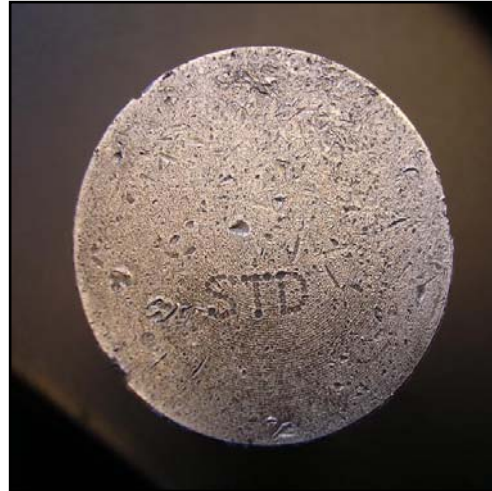
4. After cleaning the deposit from the top of the piston damage to the piston was visible

Top of new piston

Top of damaged piston

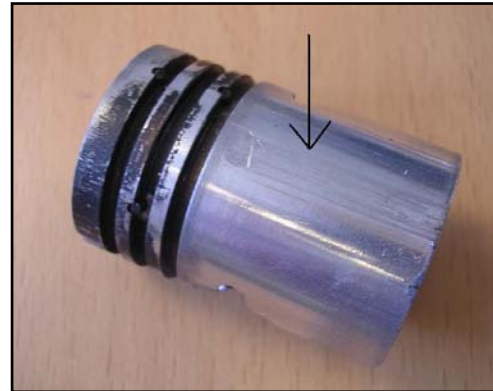
5. The piston showed a broad groove, material has been removed.

Piston showing a broad groove over the full length
