# PRACTICA

Foundation

## Report

### Rope Pump follow up, Motorized Rope Pump & Manual Drilling in the Casamance region, Senegal

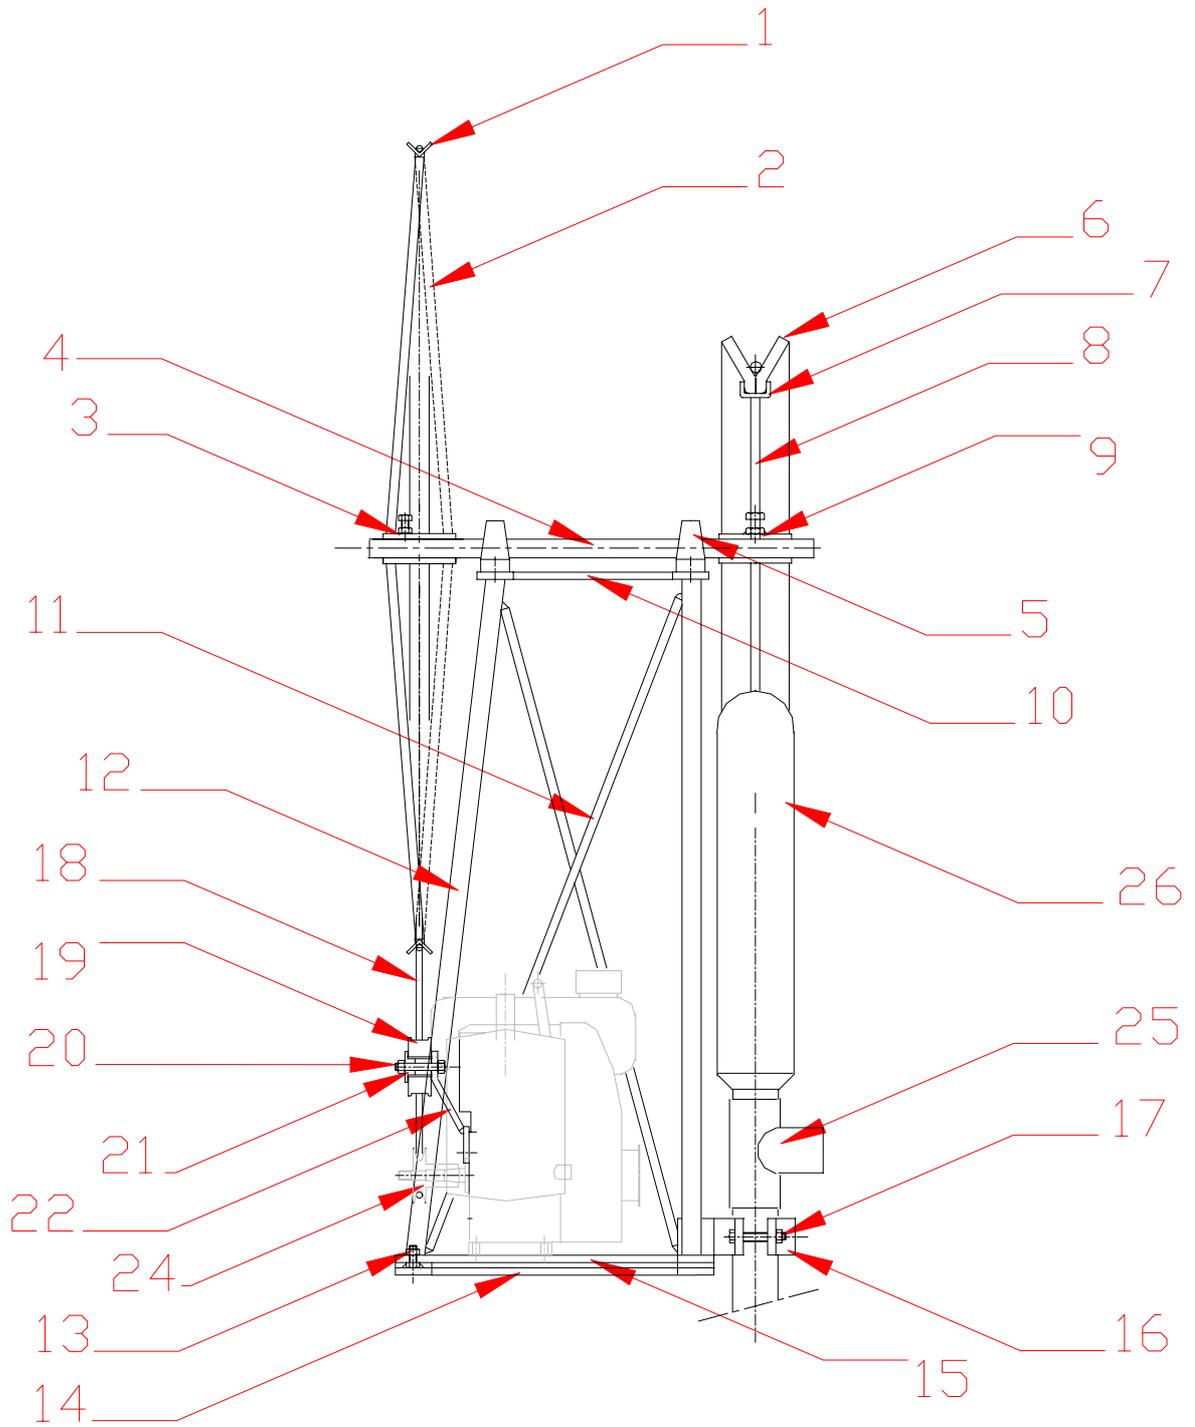
Side view

# Drawing Motorized Rope Pump

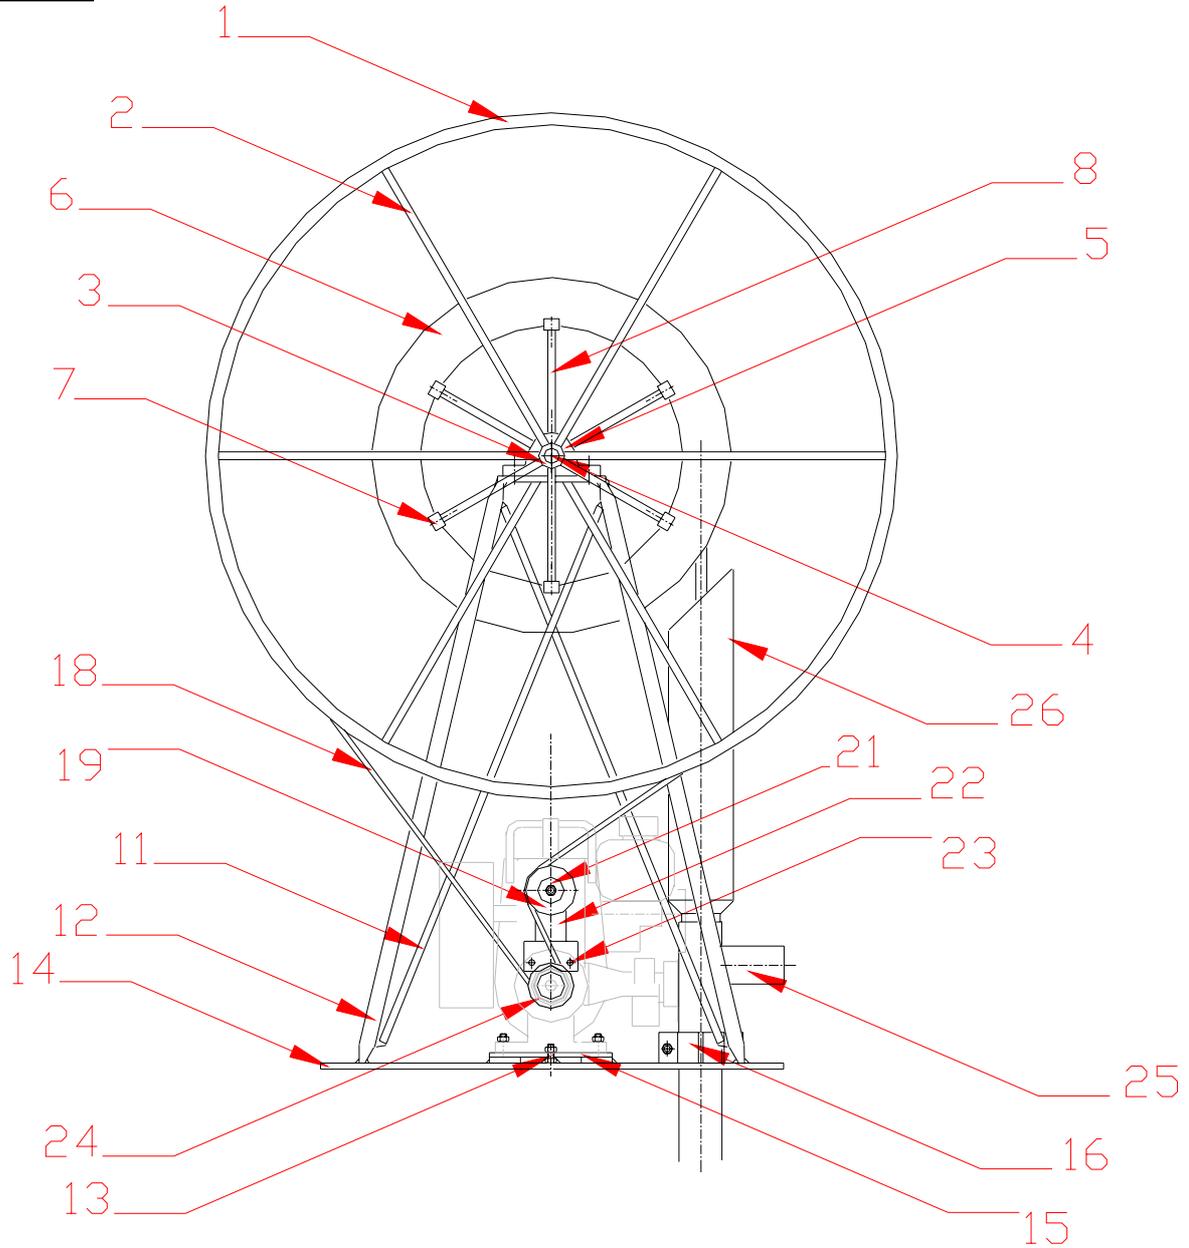
Front view

1	Motor wheel, angle iron 20 x 20
2	Spoke motor wheel, round bar 10
3	Bearing motor wheel, pipe 21/33 + bold & nut M8 x 25 (2)
4	Axle, round bar 20
5	Ball bearing, 20
6	Pump wheel, outer car tire 14 inch
7	Clamp pump wheel, iron strip 4 x 25
8	Spoke pump wheel, round bar 10
9	Bearing pump wheel, GI pipe 21/33 + bold & nut M10 x 25 (2)
10	Bearing support, iron strip 8 x 40
11	Frame Support, reinforcement bar 10
12	Structure, pipe 15/21
13	Bold & nut M8 x 25 (engine M8 x 40)

14	Structure support, iron strip 8 x 40
15	Engine support, iron strip 8 x 40
16	Raiser pipe clamp, iron strip 8 x 40
17	Bold & nut M8 x 62
18	Round belt, Poly Urethane (PU) 7mm
19	Idler pulley, brass 22/60
20	Bold & nut M8 x 54
21	Idler pulley bearing, iron 8/21/34
22	Idler pulley support, iron strip 8 x 40
23	Bold M6 x 20
24	Motor pulley, v-shape 36
25	PVC T & reducer
26	PVC pipe
