Production and testing of an animal driven deepwell pump

17 March 2007

Jan Nederstigt / PRACTICA foundation

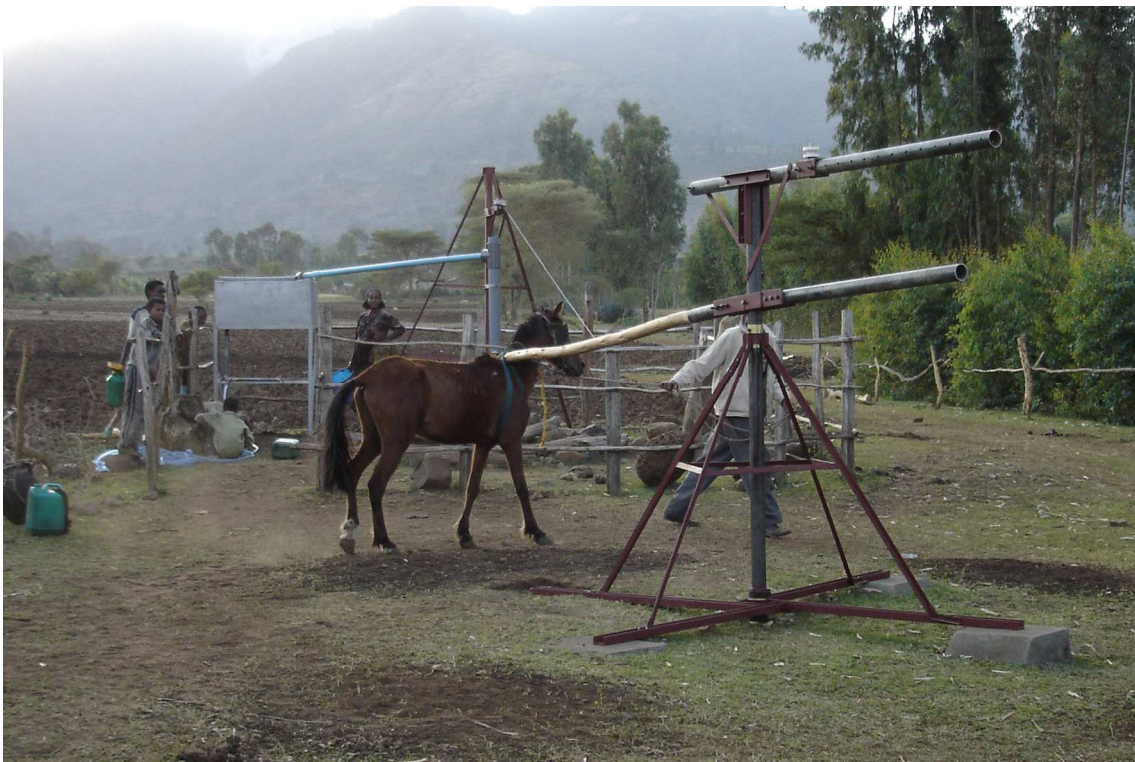
foto: Testing animal driven pump in the vicinity of Butajira
